Majuro Sewer Outfall
Condition of Existing Damage
March 2008.

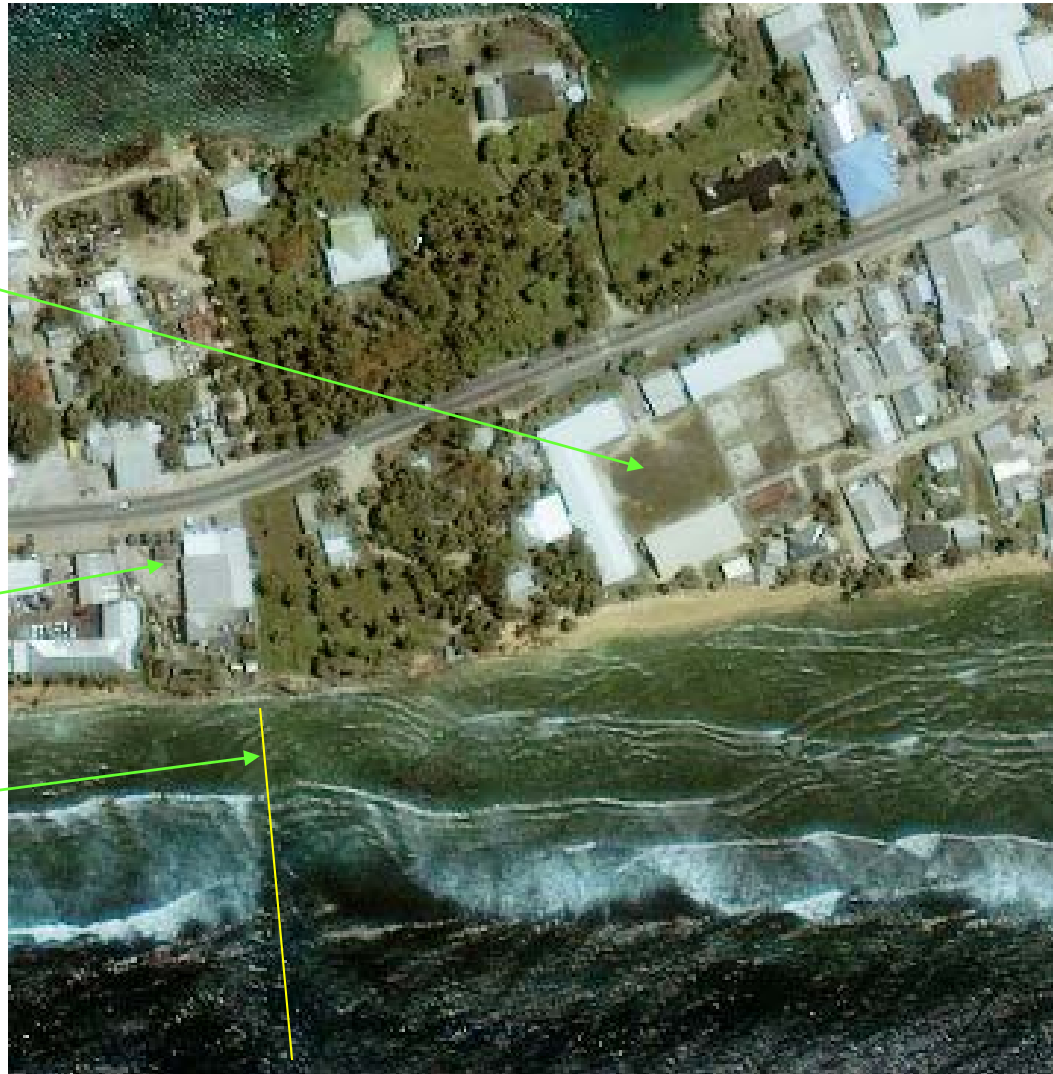
Location

(With visible
trench erosion)

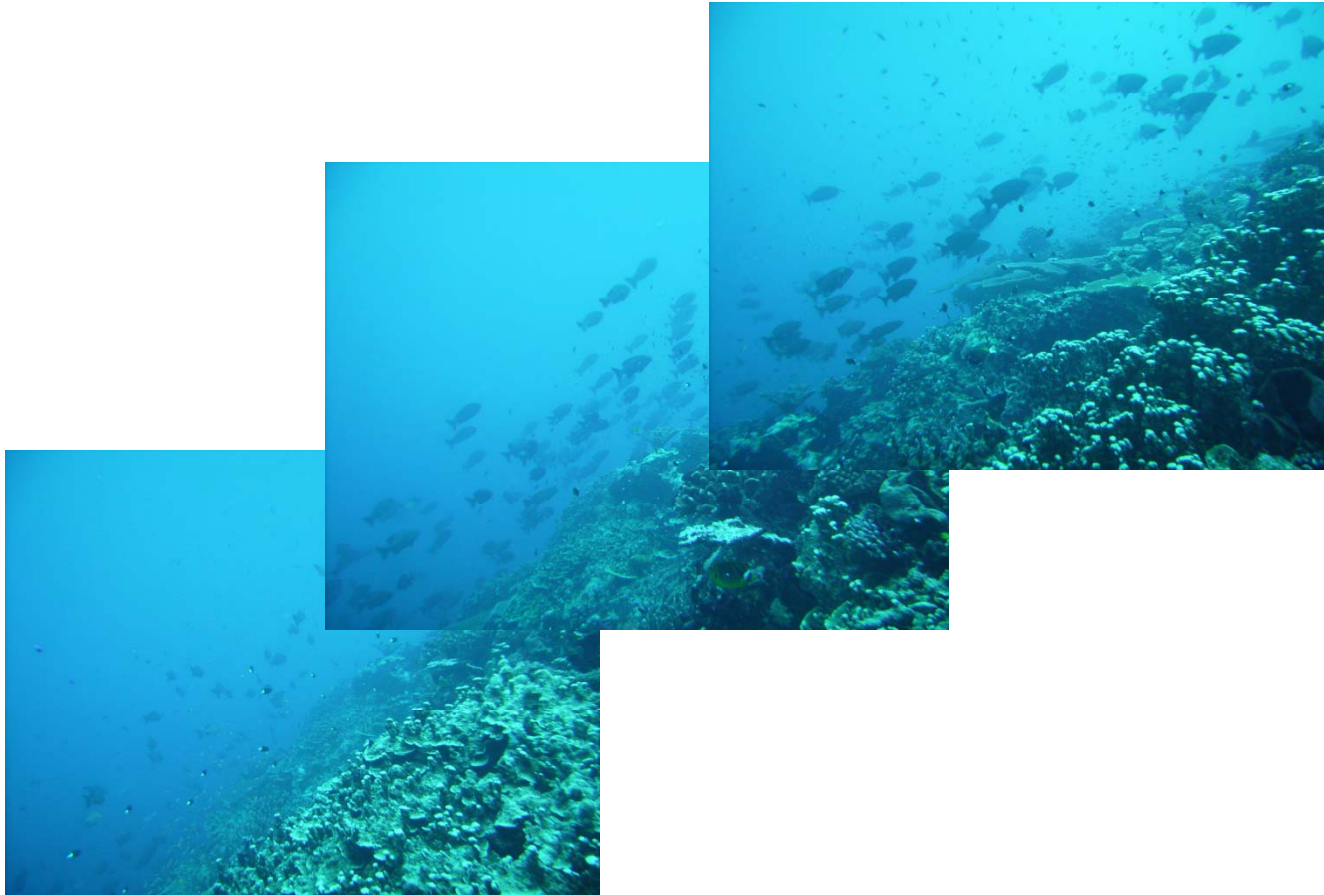
35 feet down on the edge

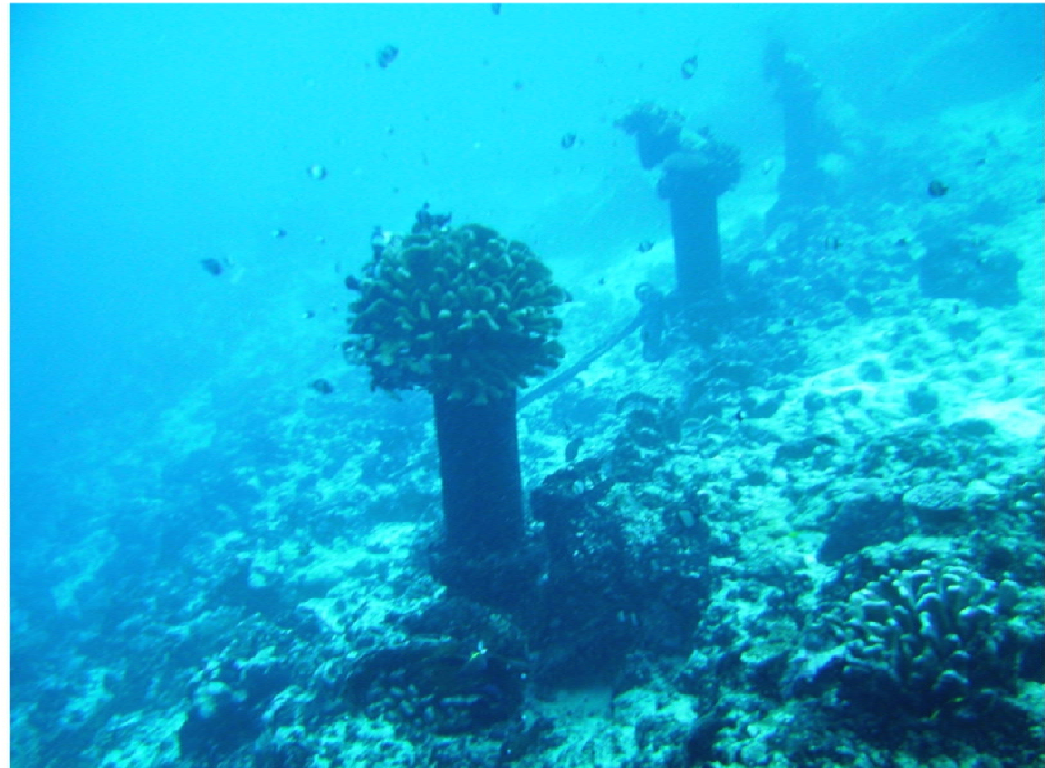
The Outlets.

1 of 2 Branch lines

The end of the outfall in approx. 35 ft of water consists of two branch lines separating in a 'Y' formation. The pipe project from the junction point and come to a vertical 'Tee' forming the first of three outlet vents. The delivery pipe continues on to the next two outlet vents but as the pipe exits each vertical tee the pipe diameter reduces to maintain the pressure in the line to force the sewerage to exit the outlet vents.

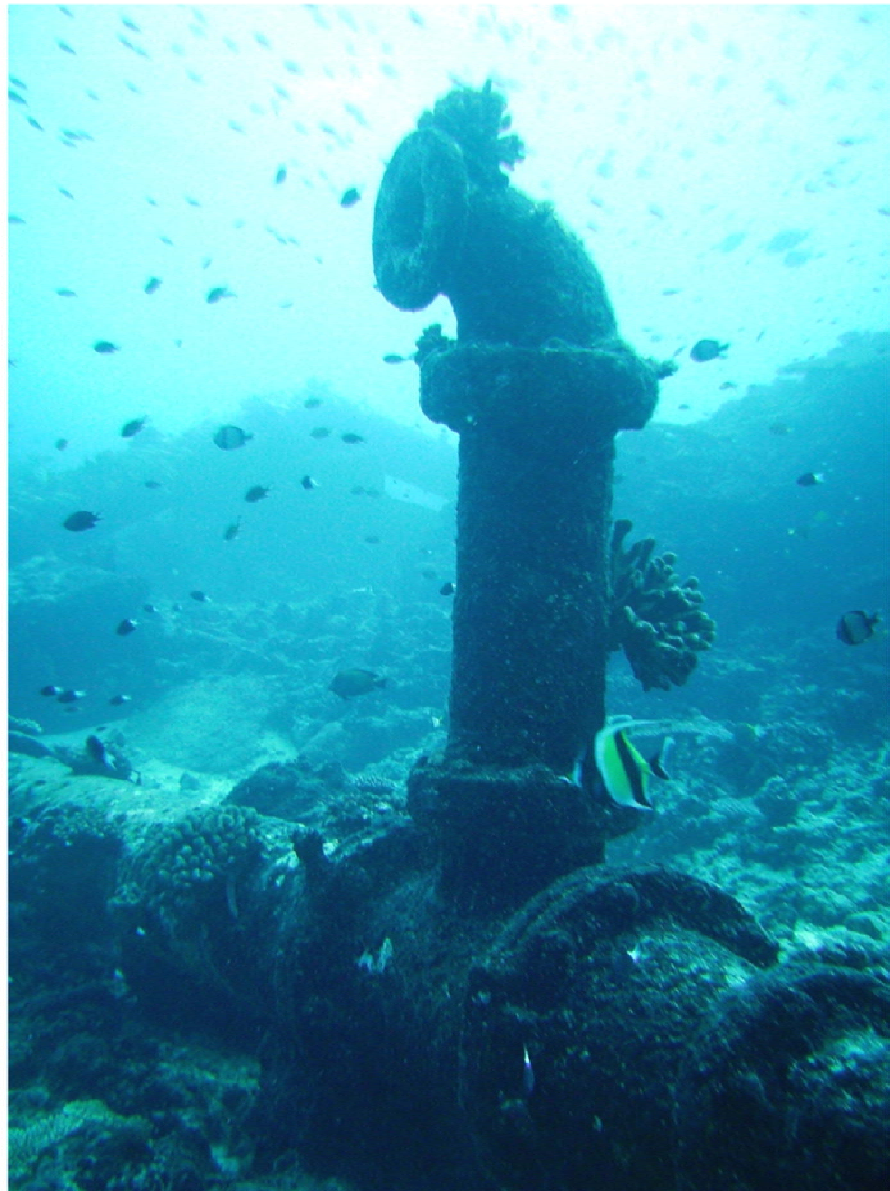
Outlet Vent Details

Here the branch line delivery pipe enters from the Left into the vertical Tee. Exiting from the vertical Tee on the right side the delivery pipe diameter is clearly reduced in size to maintain pressure in the pipeline.

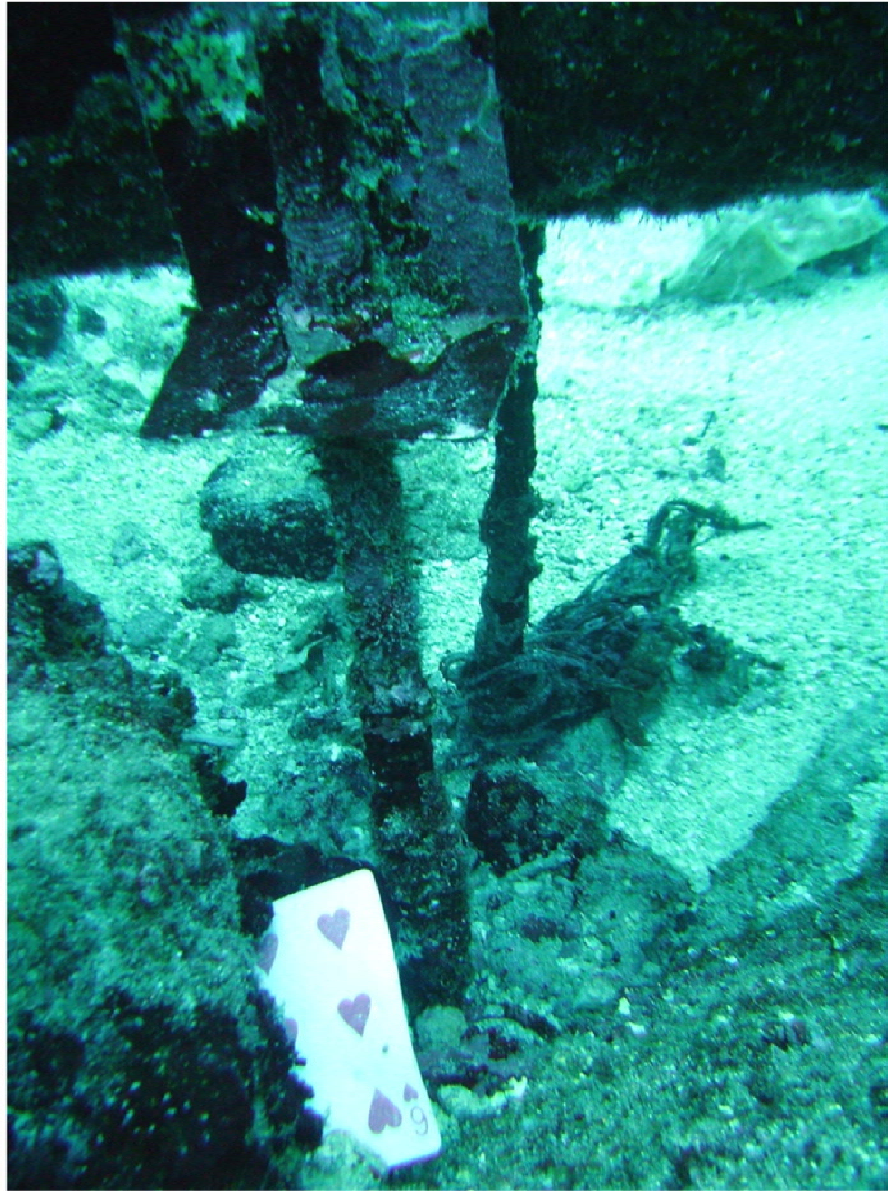
Pipe Anchor System

Here we show one method used to hold the pipeline in position. These are just threaded rods drilled into the coral reef with a saddle type strapping band clamped over the pipeline. Many of these components have failed due to corrosion and abrasion.

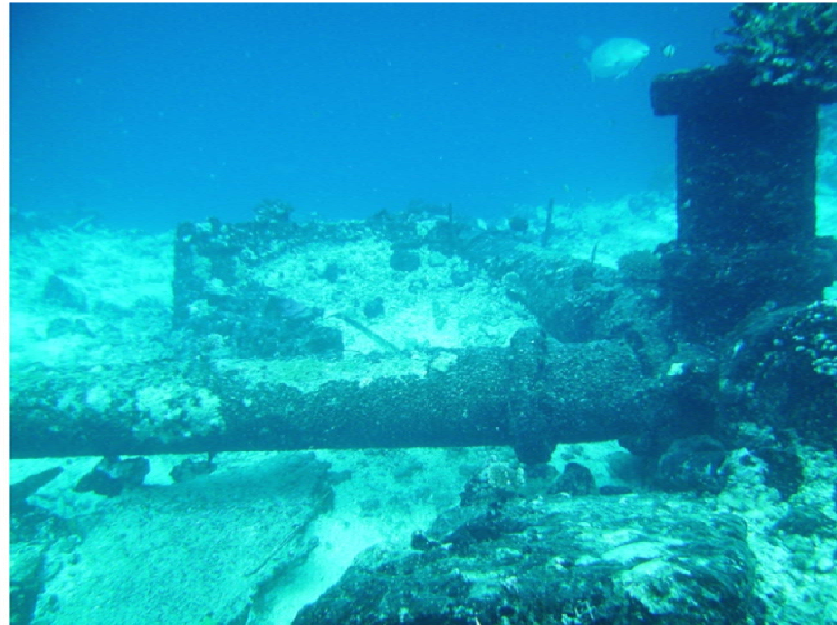
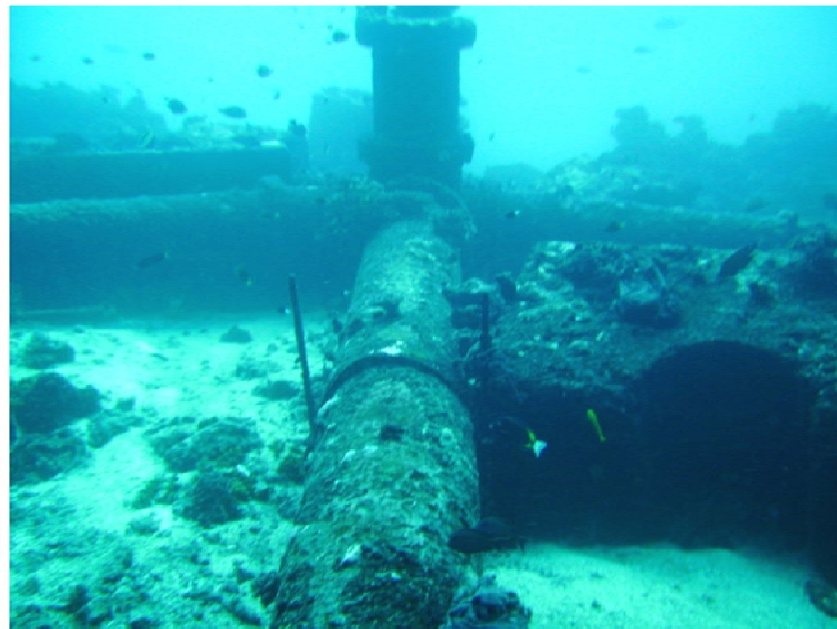
The Outlet Junction

Two views of the outlet junction.

The top view is looking towards the deep water and over the edge.

The bottom picture is looking back to the shore and the surf zone. Notice the concrete saddle weight lying alongside the pipeline.

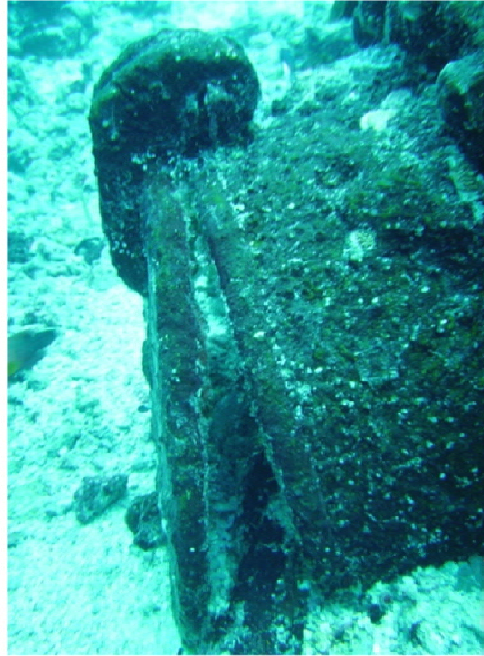
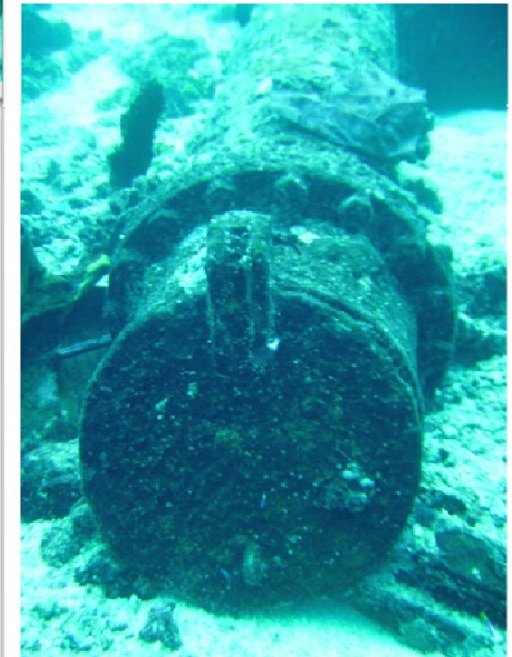
The Emergency Exit

Two photos of the flap valve on the end of the central line. This valve has been seized in this position for many years and has not worked in a long time.

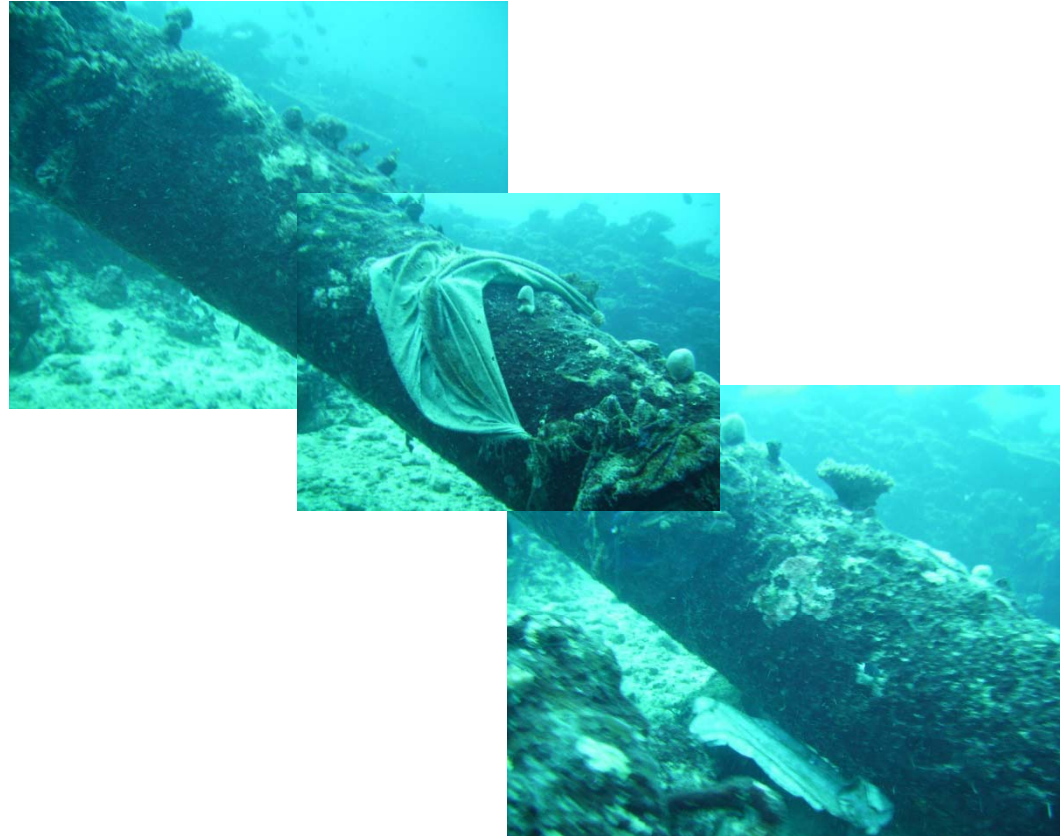
Heading Back to Shore

Much of the pipeline that is undamaged remains unsupported over the length of the line. There are very few holding down anchors still able to hold the pipeline on location.

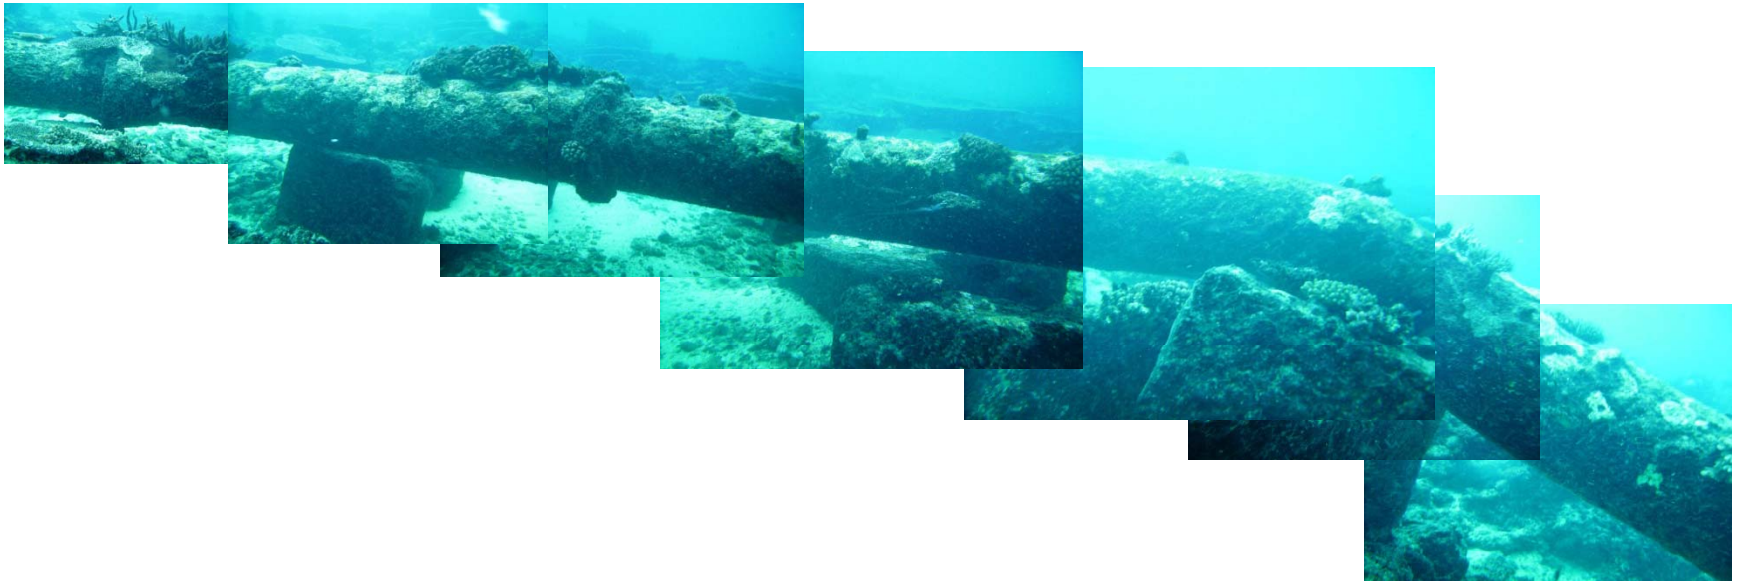
From the Surf Zone and over the first ledge to the outlet vents.

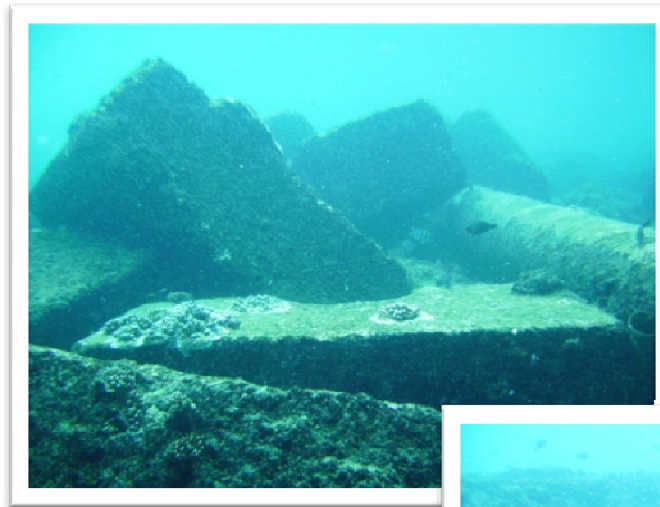
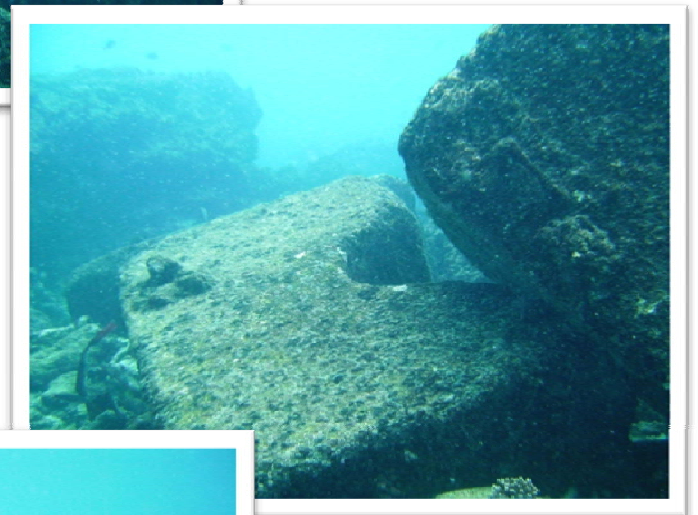
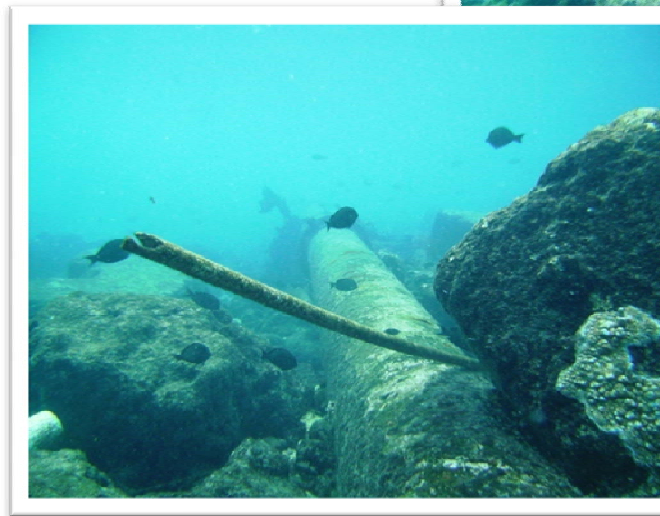
Concrete Saddle Weights

The majority of the concrete saddle weights that were made to sit under and over top of the pipeline are no longer in their original intended positions. Many have been cast aside because whatever method that was used to hold them in position has failed. Over the years as the restraints began to fail, the concrete weight slowly began to 'Dance' up and down on the pipe material as they were affected by the forces of the waves and turbulence generated.

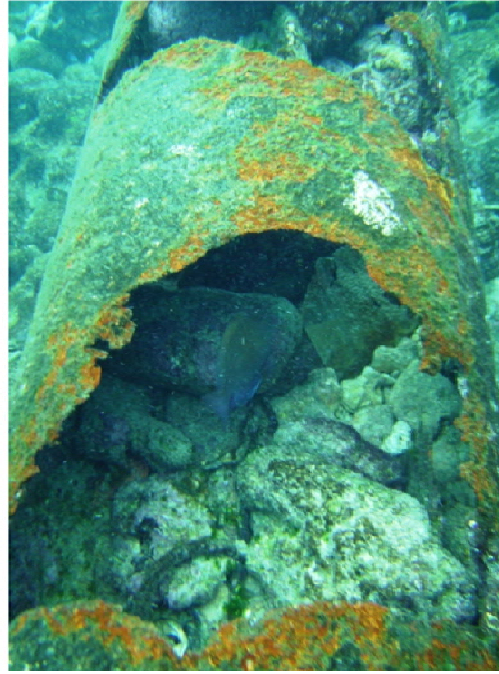
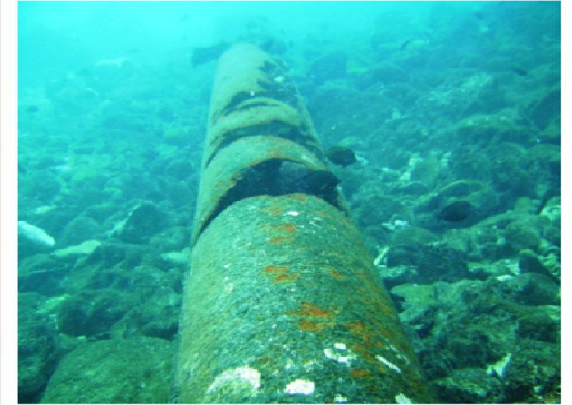
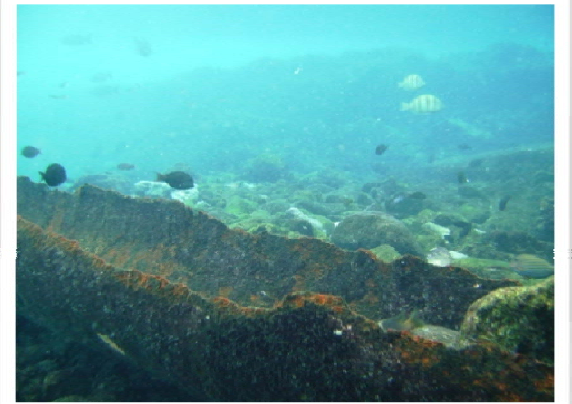
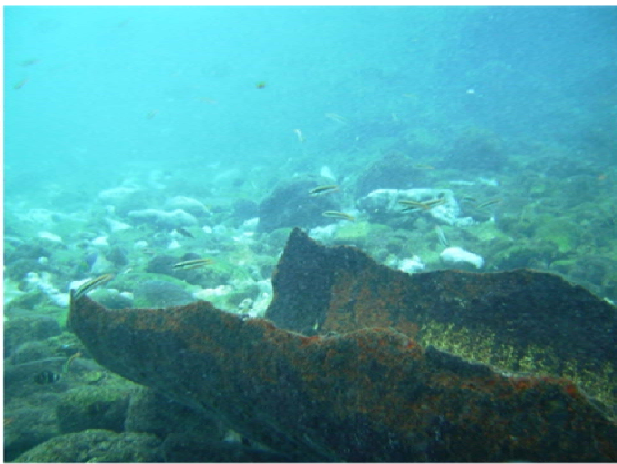
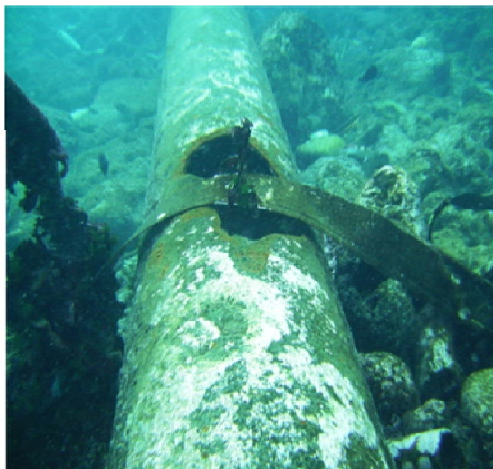
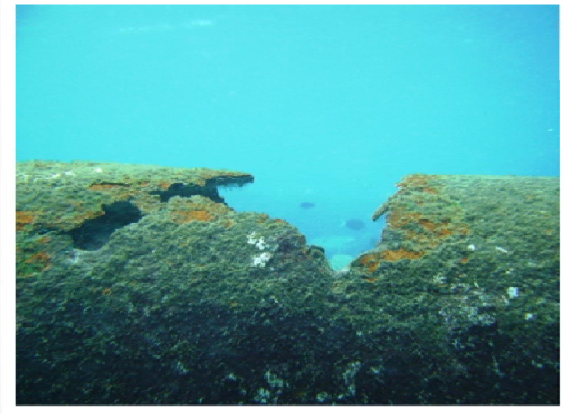
Pipe Damage

Abrasion and impact damage have caused many sections of the pipeline in the shallow region to very thin and eventually break through the pipe wall. In some areas large sections of the top part of the pipeline have been removed and in other areas whole sections of the pipeline have been lost.

- The system could be repaired using the same materials in a similar fashion but with improved components and construction.
- The damaged sections could be replaced with heavy duty plastic pipes as used elsewhere around the world for this purpose. Anticipated costs for this work would be less than \$1,000,000.
- A whole new outfall could be constructed adjacent to the existing outfall. Anticipated costs would range from \$1 - \$3 million.
- The best and most protected solution would be to use a horizontal directional drilled tunnel through to any deeper depth on the reef wall but the price range for this type of work is in the range of \$2 – \$7million.

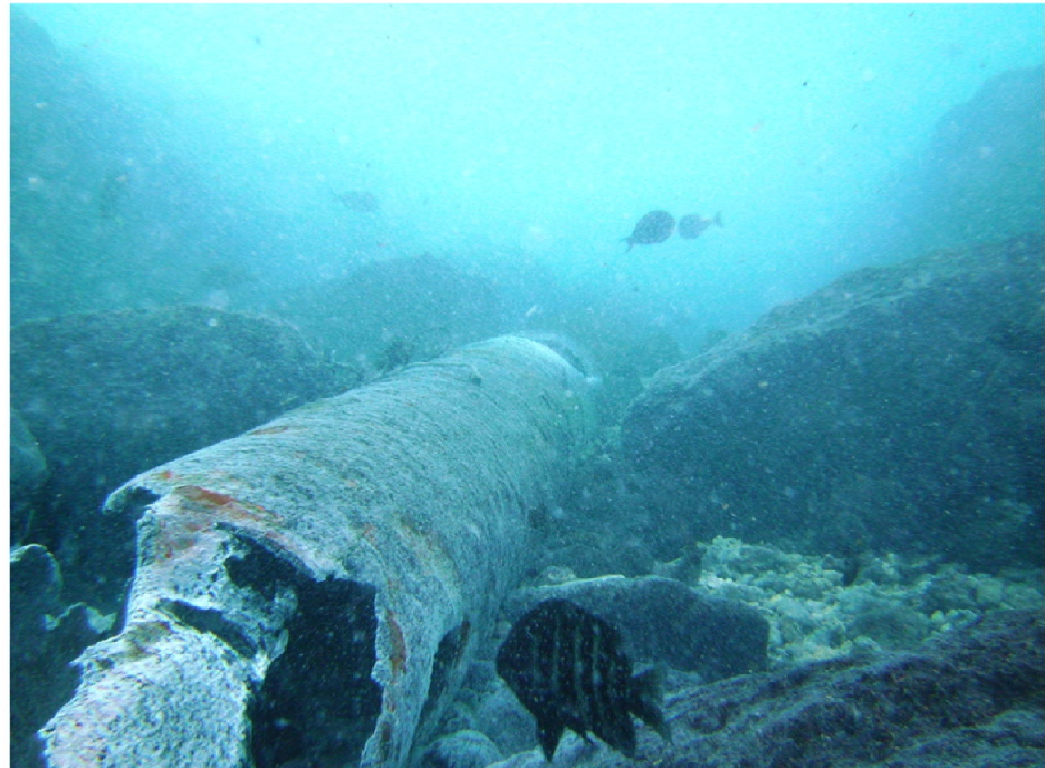
Emerging from the Reef.

The pipeline is buried in an excavated and filled trench from the pumping station and out through the exposed surf zone. The fill material put back into the trench has been washed out over the years . This has exposed the pipeline to very active wave action along with abrasion and impact damage from the material used to fill the trench. This picture shows the damaged and broken pipe emerging from the remains of the filled trench. Approx. 40 ft or 12 m of trench has been washed out.

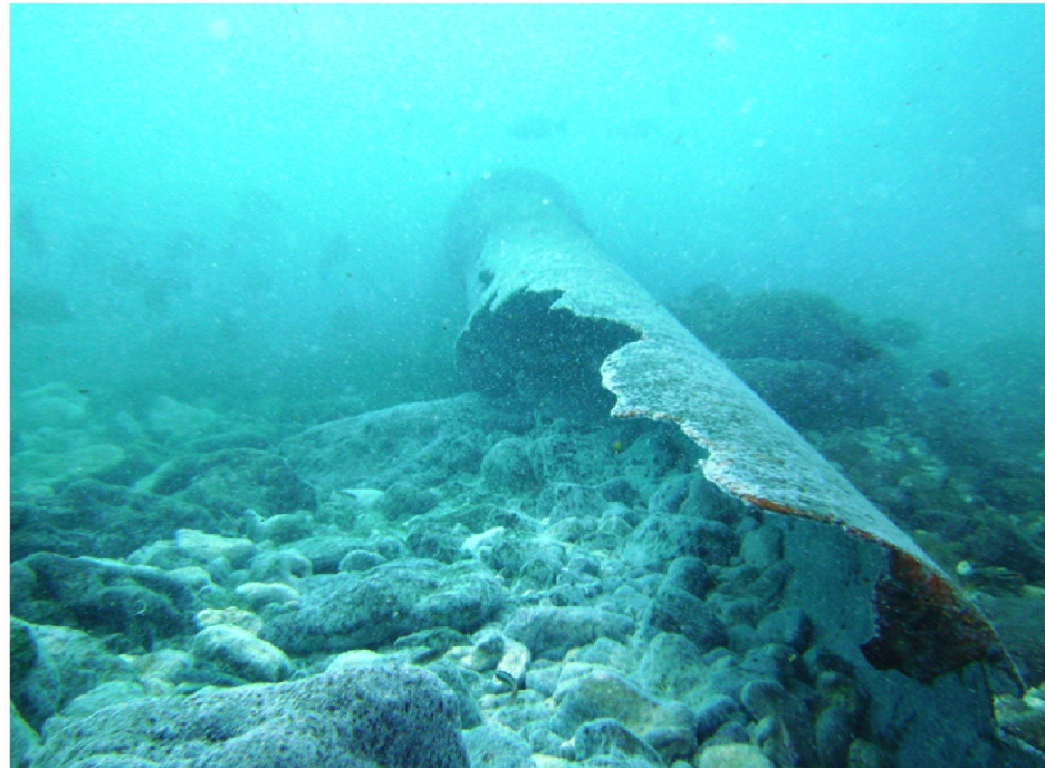
Existing Outlet

Sewerage currently exits the damaged pipeline within the remains of the washed out trench in the surf zone. The whitish coating on the seabed indicates this. The lack of this coating elsewhere along the pipeline indicates that the pipeline has been damaged for many years.

- It is possible to repair the pipeline but it will be difficult.
- The pipeline now discharges into the eroded trench in the surf zone. This has the potential to contaminate the reef area adjacent to the outfall.
