# Wotje Wind Mast Site Installation and Commissioning Report

For: MEC/ADMIRE

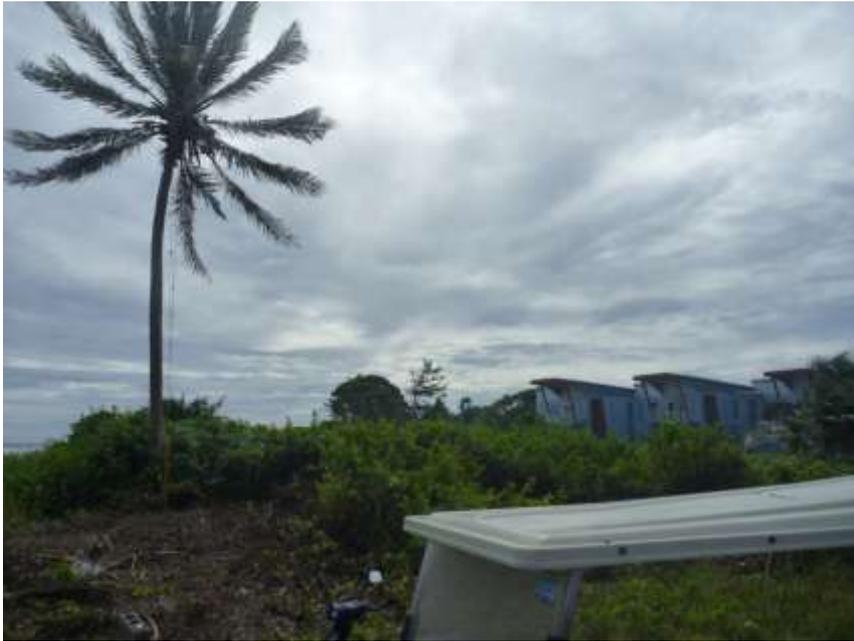
Mast location looking East:

It was recommended that the coconut tree 20m to the east should be removed as soon as possible as it may interfere with wind readings, particularly at the 20m level.
